# Lets Face the Facts on VDMA Guidelines

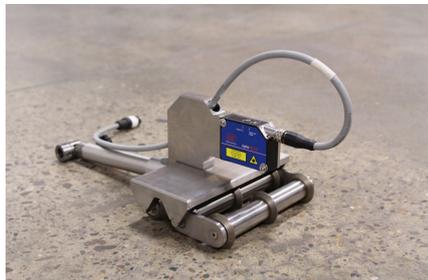
Pic. 1: Here it is the **AlphaPlan** perfectly engineered VDMA ('FX') measuring tool.

The VDMA survey tool has been specifically designed to take into consideration the width of most if not all of VNA MHE wheels, (not the wheel size).

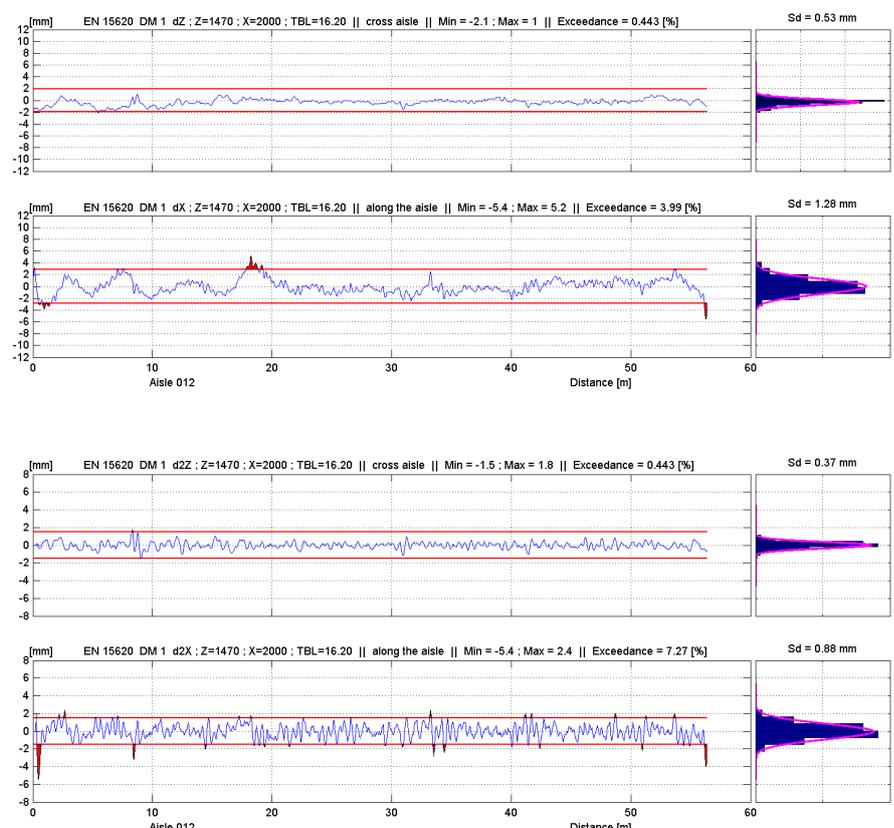
Diag 1a. Survey Graph EN15620 or DM1 (the MHE in this case were unable to operate as specified).

Here we can see the aisle 012 specified as DM1(copy and paste EN15620) by the same company acting as the consultant, flooring contractor and grinding contractor. After additional remedial work to the VNA aisles the client again questioned the work as the MHE failed to operate as specified.

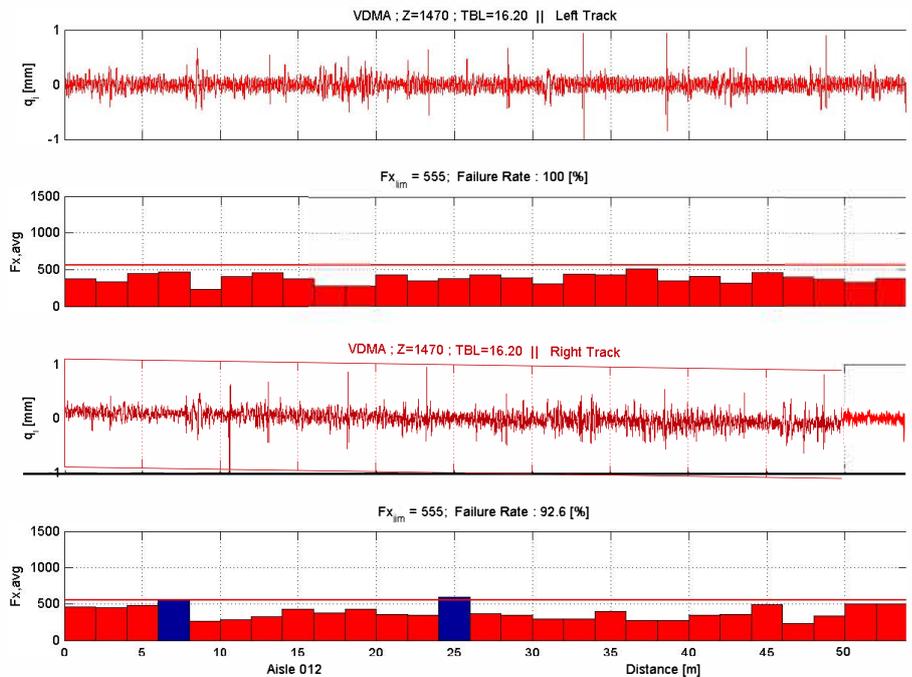
Here we can see the same aisle surveyed under VDMA ('FX' Short Wave length) proving failure in the majority of the floor, it is easy to understand why the MHE fails to operate in this case, hence the client could not operate at full height and speed, for this reason he had no choice but to dramatically reduce the speed and height of his VNA trucks.

Diag 1b.  
Survey Graph surveyed under VDMA ('FX') (the same floor Aisle 012 as the DM1 specified)

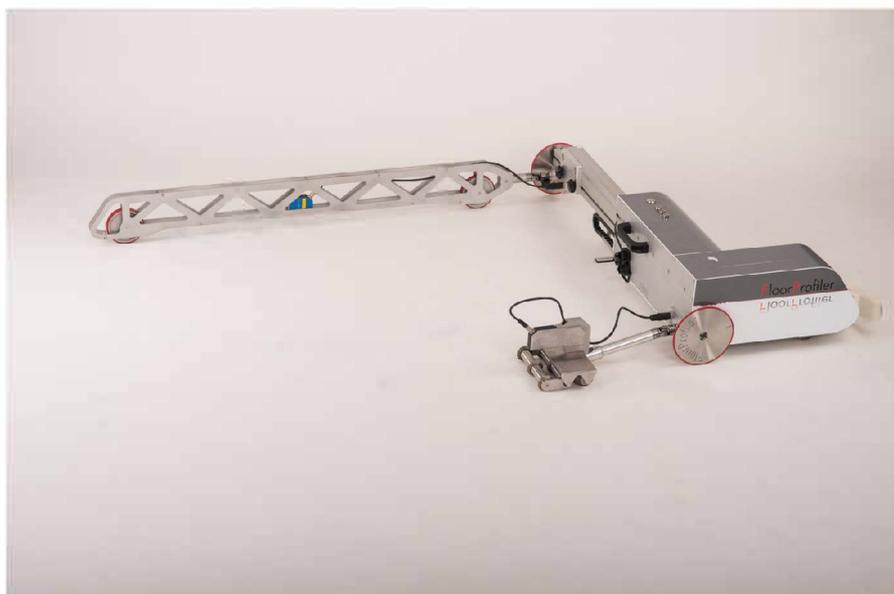
Pic 2  
Shows the FloorProfiler with the DIN 15 185 and the VDMA ('FX' Meter) tools.
